AGARD REPORT 809

POD Assessment of NDI Procedures Using a Round Robin Test

Published January 1995

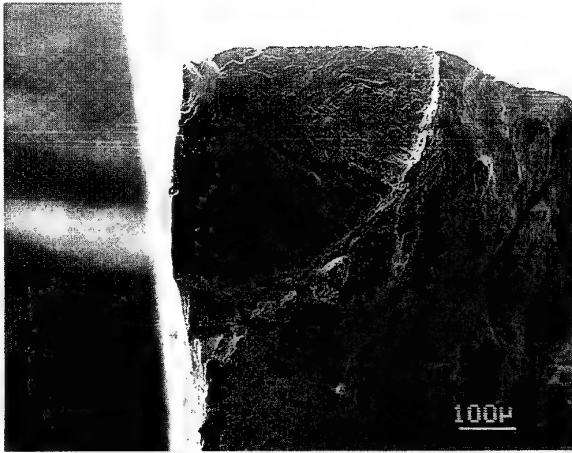
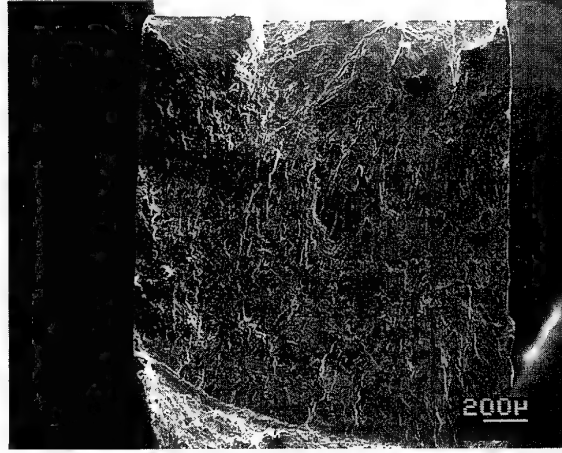
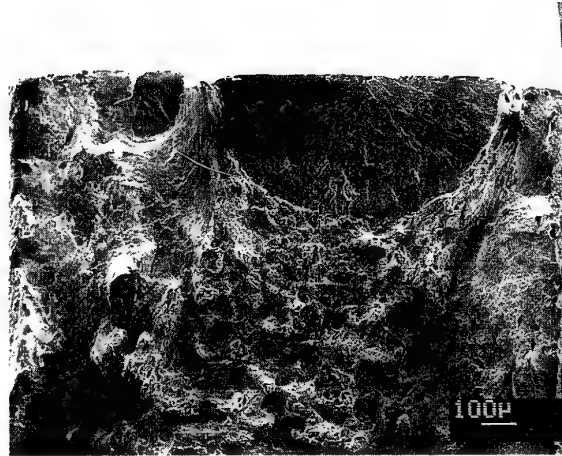
Figure 4. Examples of different crack types in the bolt holes

Destructive tests and examination of fracture surfaces indicated that most cracks initiated near the edges of the holes and formed corner cracks. Often, initiation occurred at the bore of the holes and grew radially inward towards the centre of the component. There were cracks which did not touch the top or bottom surfaces and these were termed middle cracks as well as cracks which touched both surfaces and were referred to as through cracks. Examples of different crack types are provided in Figures 4 and 5. Figure 6 provides the distribution of different crack types as a function of crack length indicating that the majority of cracks were small (less than 0.5 mm in length) corner cracks. Most holes had a single crack but multiple cracks, as many as seven, were also seen in many holes. Some cracks did not occur along the radii of the discs; many of these were initiated at what appeared to be voids or inclusions in the material and were often accompanied by larger cracks on the radii. Some totally internal cracks as well as outward propagating cracks were also seen.

The shape of cracks varied depending on their location; middle cracks were mostly semi-elliptical, corner cracks appeared as a quarter of an ellipse and through cracks were close to rectangular in shape. A combination of the above shapes was often seen in the case of multiple cracks. The crack size was measured in terms of total area of crack face and the maximum length. In cases where failure did not occur through a crack, the bore surface of the bolt hole was examined and if a crack was found, the crack length at the surface was measured.

a) A corner crack

b) A through crack

c) A middle crack

d) A multiple crack

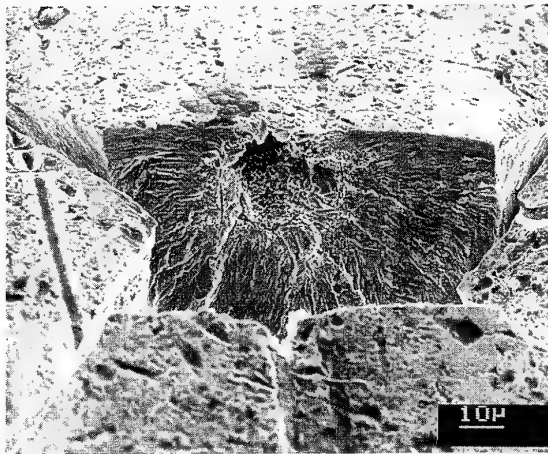
Figure 5. b) A crack initiating cavity

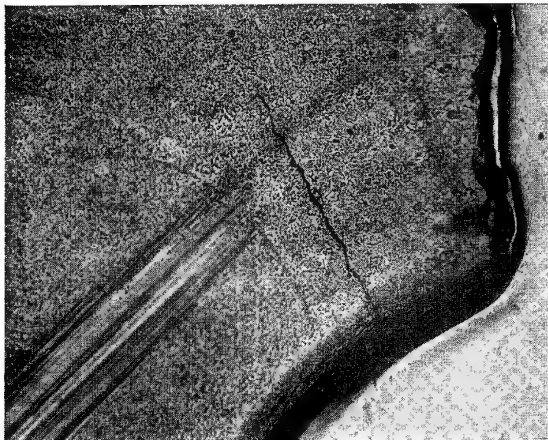
Figure 5. c) A cellulose-acetate replica of the disk surface, showing a crack

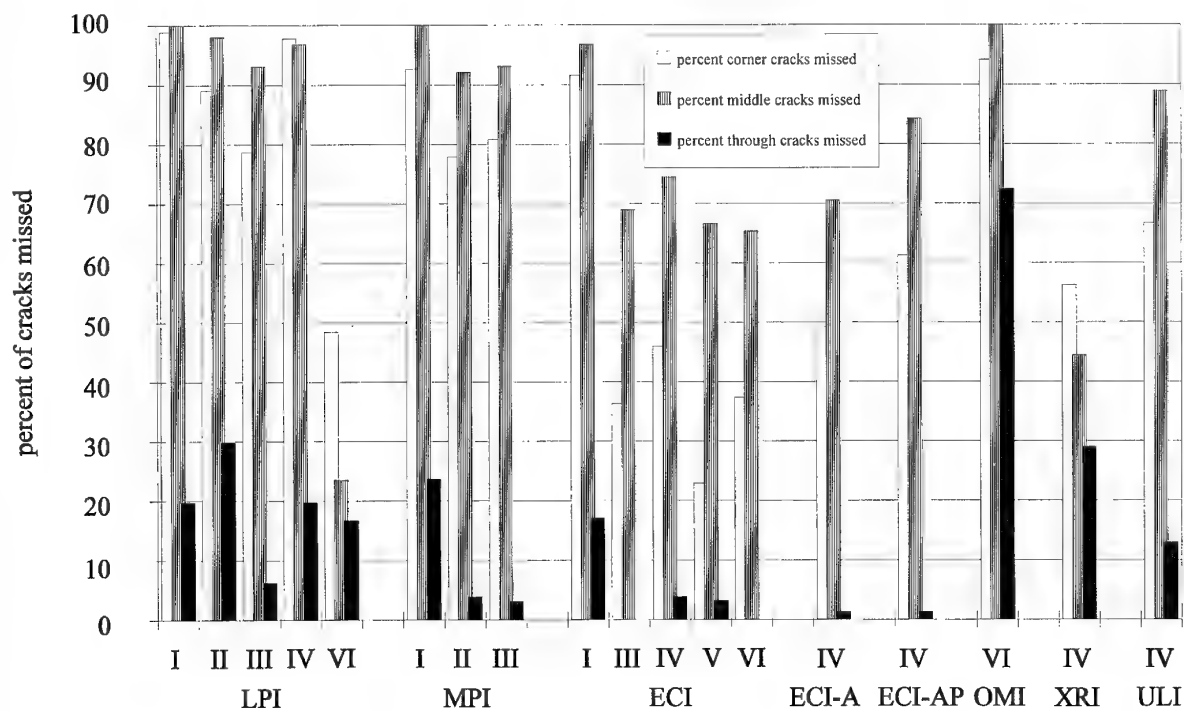
Figure 7 shows histograms of the percentages of cracks missed by each inspection procedure, organized by crack type. Through cracks were the easiest type to detect by all techniques, because they were generally larger and open to surfaces. However, only eddy current inspection was able to detect more than 90% of through cracks. Middle cracks were the hardest to detect for all methods, mainly because these cracks were mostly small and it was physically difficult to access or view the bore surface of the holes. There were a large number of small (<0.5 mm) corner cracks which were missed by all methods. In all cases, the eddy current inspections were the best performers.

Figure 7. Histograms of percentage of cracks missed for each crack type, by each inspection procedure

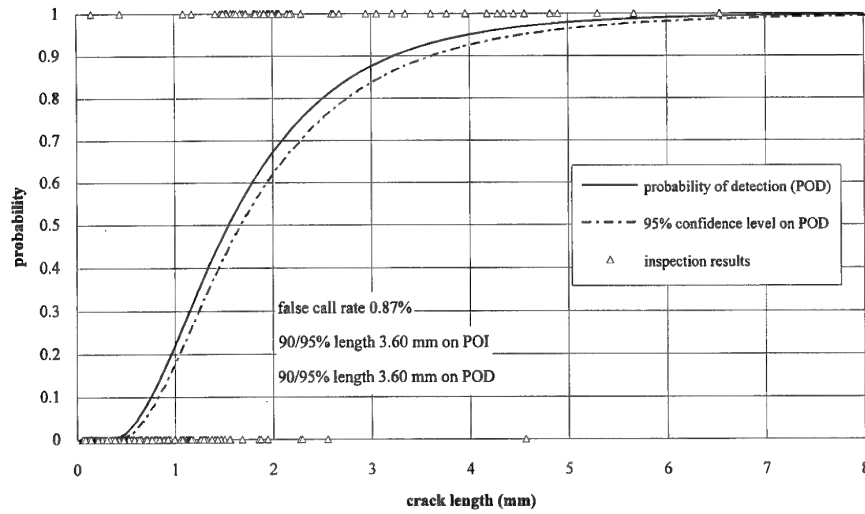
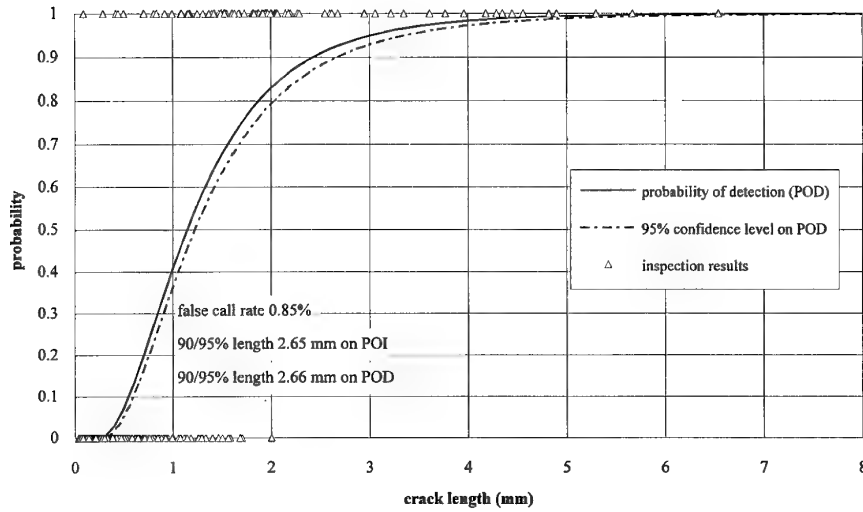
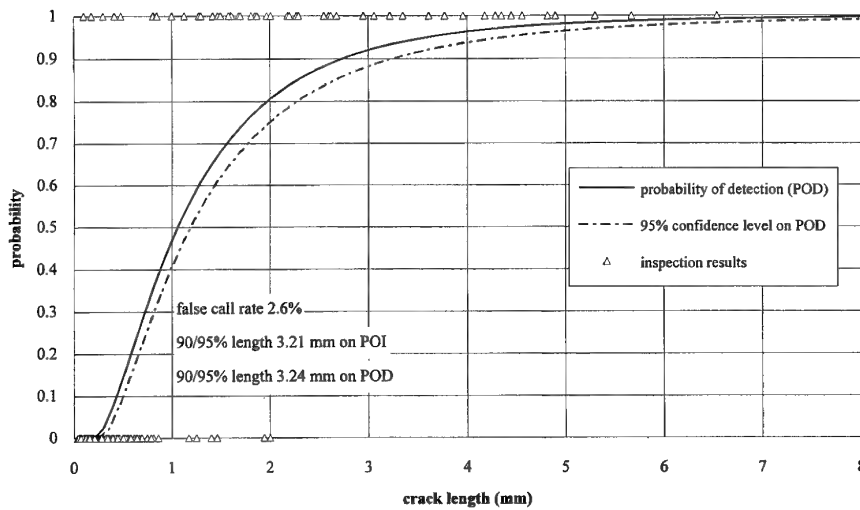
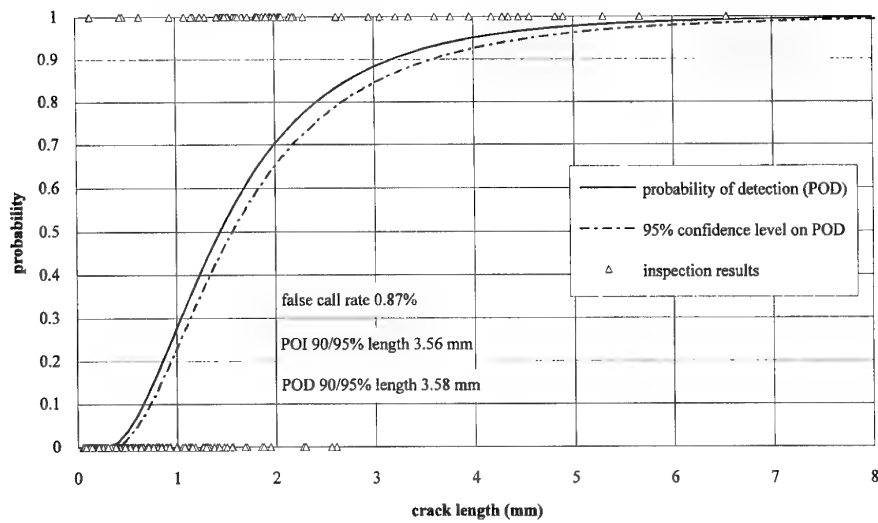
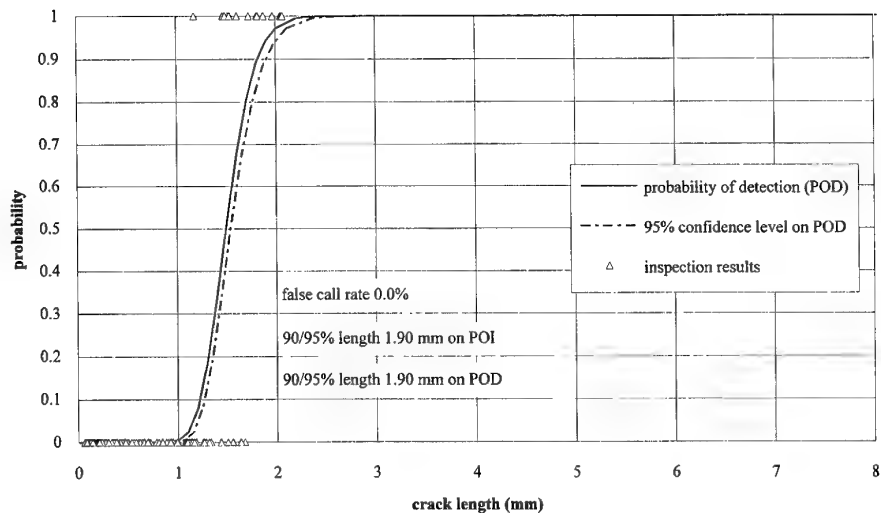
The false call rates for liquid penetrant inspections were less than 3% and therefore only the POD curves are shown in Figures 8-12. The LPI POD results of different organizations were very similar with the exception of organization VI which was different. The LPI data of this laboratory obtained on 160 bolt holes, which happen to contain only small (<2 mm) cracks, showed only a 11% detection rate with no false calls. The other four laboratories had detection rates of 25-28% and false call rates of 0.9-2.6%. Despite the low detection rate for that one test site, at 1.9 mm, the 90/95% crack length was less than those for the LPI processes of the other four laboratories which had 90/95% values in the range of 2.7-3.7 mm. These are close to the values obtained in the earlier investigation using similar disks [1,9] implying that the LPI results can be very reproducible if the procedure remains similar. The lower 90/95% crack length for organization VI could be attributed to the small sample population used by that test site and the fact that there were no missing cracks larger than 1.8 mm in their data base. With the exception of a 4.6 mm crack which was missed by the laboratory I, all cracks larger than 2.6 mm were detected by the LPI procedures employed. Since the LPI method relies on penetration of a liquid into cracks, the tightness of cracks may have contributed to missing a large number of small cracks.

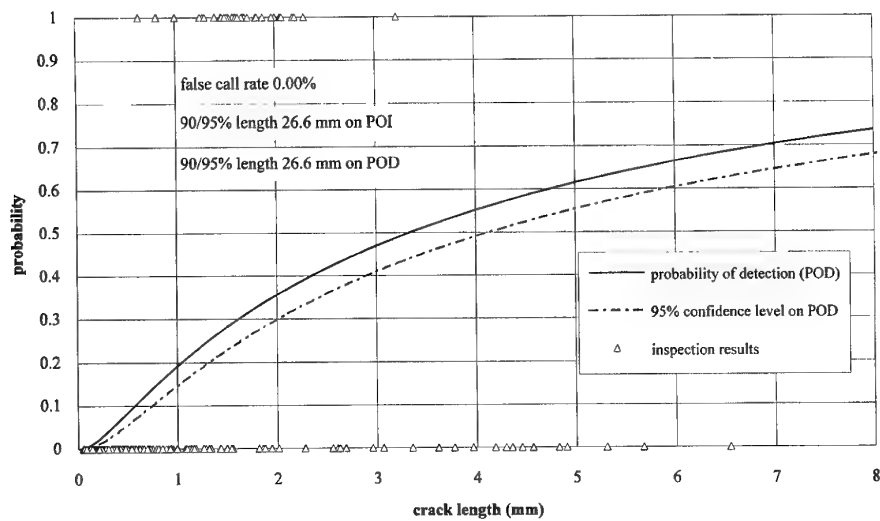
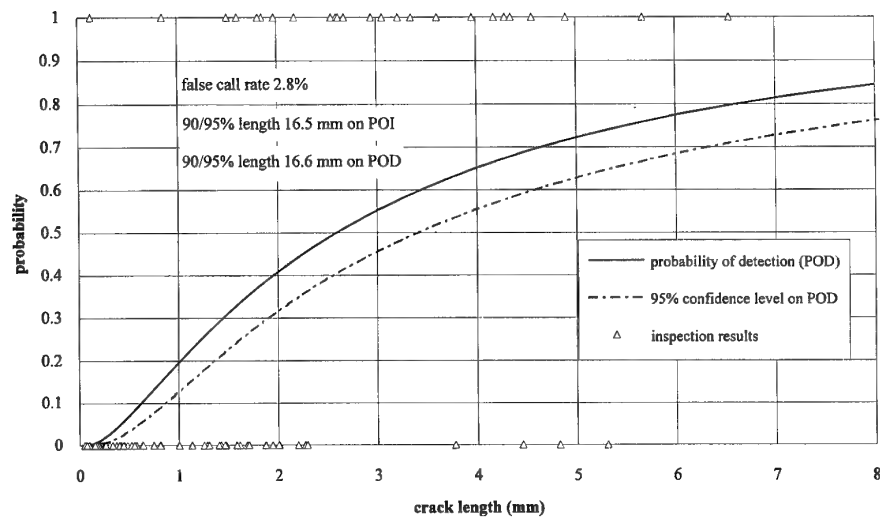
These inspections produced low false call rates but missed a large number of cracks as seen in the POD data (Figures 23,24). The largest cracks missed were 6.6 mm for the optical technique and 5.3 mm for the X-ray method. The 90/95% crack length found for the optical method was 26.7 mm and for the X-ray technique was 16.5, indicating that these methods are not appropriate for detecting LCF cracks in engine components of the type investigated here. The OMI inspections suffer because of the component surface roughness, tightness of cracks and the difficulty in viewing the bore surface. X-ray inspections of these components are also difficult, due to component material and geometry and the small crack sizes.
